FACTORS AFFECTING GASKET SELECTION FOR STAINLESS STEELS IN SEAWATER

R Francis and G Byrne
Weir Materials & Foundries
Park Works
Newton Heath
Manchester M40 2BA
UK

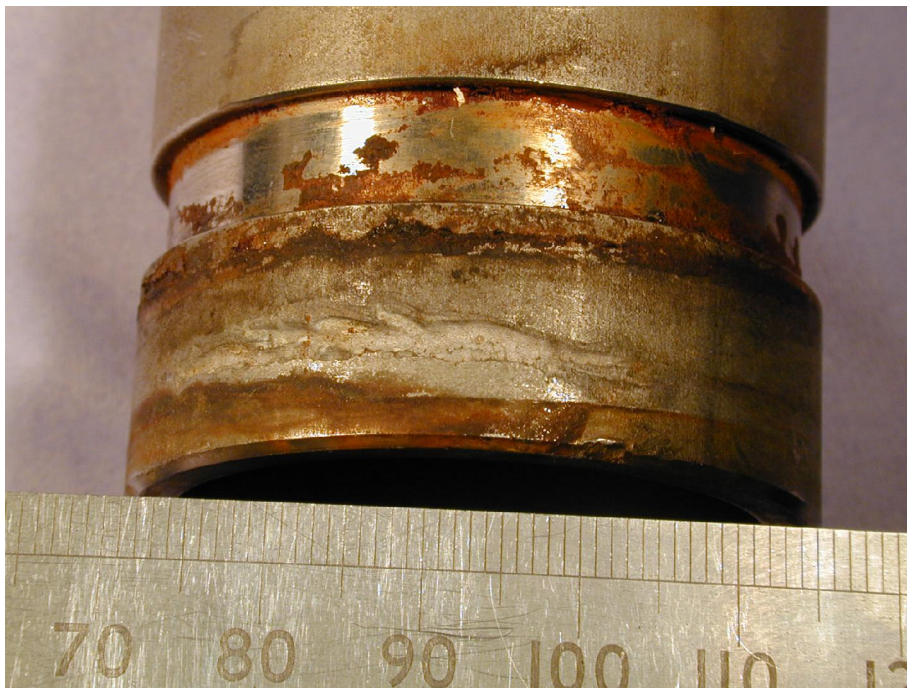
FIGURE 4 - Crevice corrosion of 316L at high pressure pipe joint.

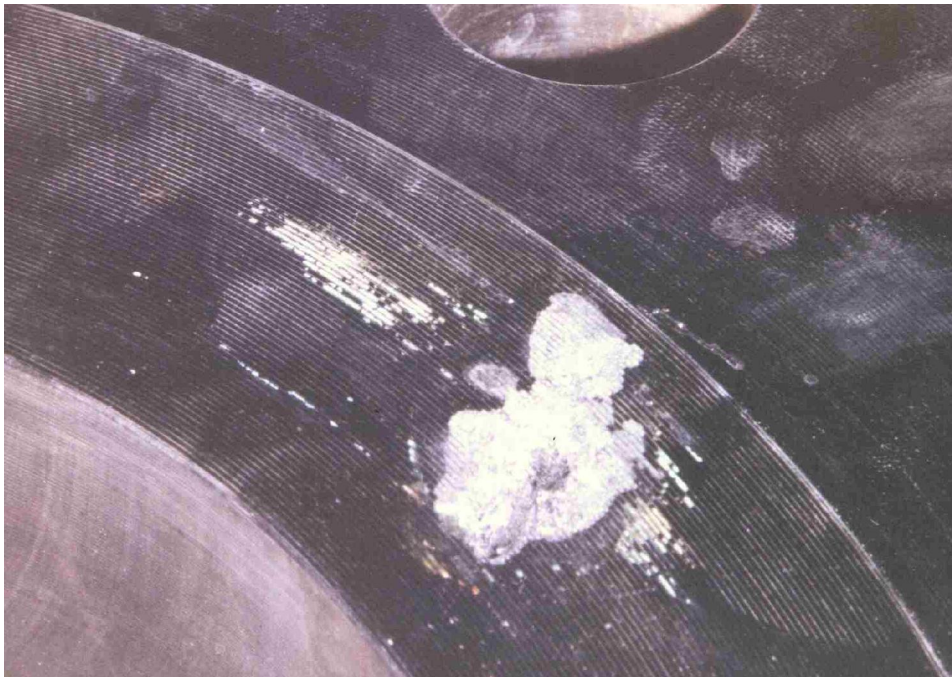
Over the last 15 years a number of problems with leakage at flanges due to corrosion have been reported for 6% Mo austenitic and superduplex stainless steels. A few of these have been due to metallurgical problems, such as sigma phase due to incorrect heat treatment¹³. However, more have concerned the use of graphite-containing gaskets in chlorinated seawater service.

Strandmyr and Hagerup reported problems with graphite-containing gaskets on 6% Mo stainless steel flanges on several North Sea platforms¹³. The problems were solved by re-machining the flange face and changing to neoprene gaskets. Shrive¹⁴ reported a similar problem on the Rob Roy/Ivanhoe platform, with superduplex stainless steel. Again the problem was solved by re-machining the flange faces and changing, this time, to synthetic fibre gaskets. The author has also

seen the problem in superduplex flanges on the seawater feed piping at an RO desalination plant in the Middle East. Figure 5 shows the typical appearance of the attack.

FIGURE 5 - Corrosion of a superduplex flange with a graphite-containing gasket.

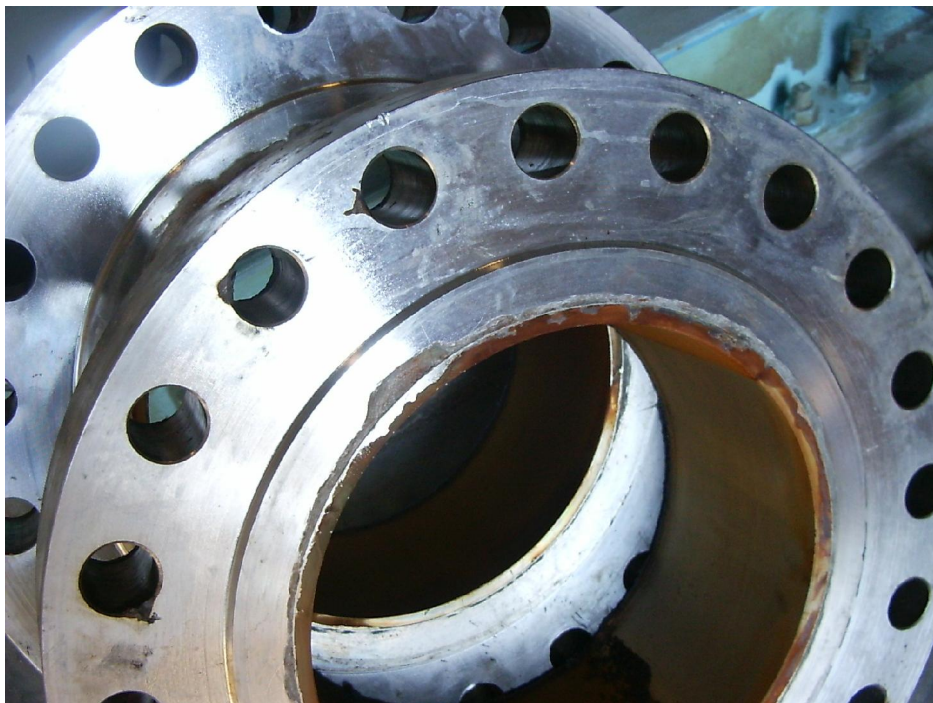
PTFE has not often been used for gaskets in seawater systems and reported cases of failures are rare. Figure 6 shows corrosion of a superduplex stainless steel flange from on RO desalination plant where PTFE had been used. In this case, the gasket was a 316L spiral wound gasket coated in PTFE, because the joint was in the high pressure section (70 bar). A change was made to a compatible metal gasket with no coating.

FIGURE 6 - Corrosion of a superduplex flange with a PTFE coated gasket.
