Coupling of superduplex stainless steel and cast nickel–aluminium bronze in sea water

R. FRANCIS

Tests have been performed at about 25°C in both natural and chlorinated sea waters on couples of nickel–aluminium bronze (NAB) and Zeron 100 (Z100) superduplex stainless steel. Two NAB/Z100 area ratios (1:1 and 1:10) were used in exposures of 60 days. The results in natural sea water showed severe localised corrosion of NAB both in the crevices and on open surfaces at both area ratios. In chlorinated sea water there was no corrosion at a 1:1 area ratio. The attack is explained in terms of the different cathodic reactions occurring in natural and chlorinated sea waters, and the metallurgical structure of NAB. Service experiences with couples of NAB and superduplex stainless steel are described and recommendations are given for the avoidance of problems.

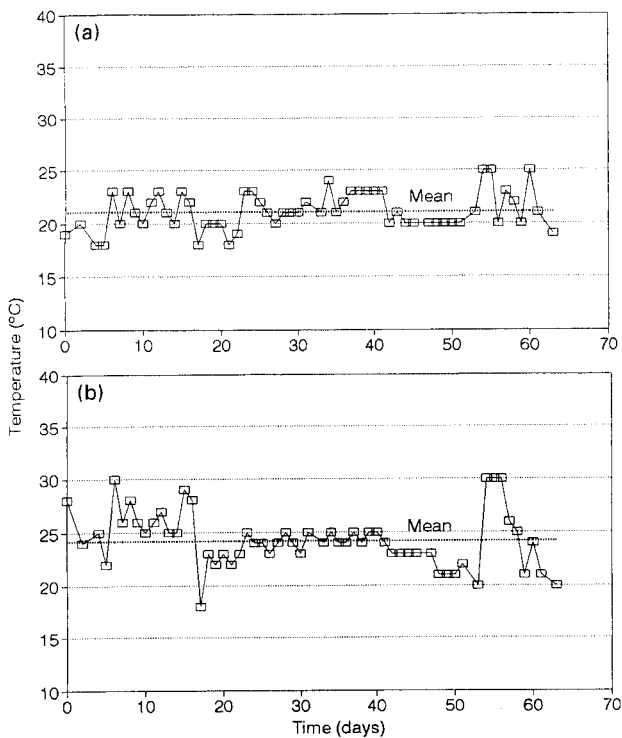
1 Temperature variation with time for (a) natural sea water and (b) chlorinated sea water

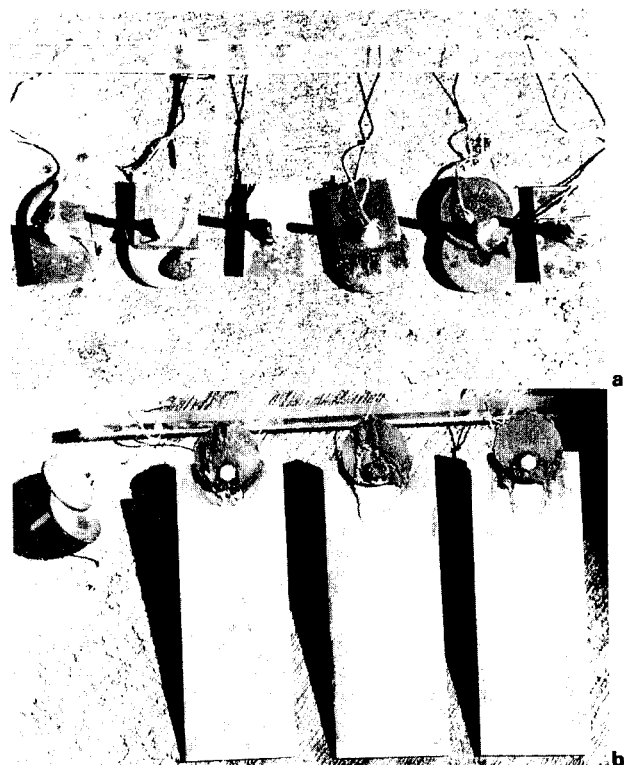
2 Appearance of galvanic couples exposed for 63 days in natural sea water

Upon removal, the specimens exposed to natural sea water looked as shown in Fig. 2a and b. The photographs clearly show the presence of fouling slime (grey/brown) and large quantities of green and brown corrosion products on some couples. Figure 3a and b shows the specimens from the chlorinated tank. These clearly show less corrosion and no fouling.

The NAB/NAB couples had a covering of slime but showed only general corrosion with no signs of crevice attack. The NAB specimens coupled to Z100 at a 1:1 area ratio all showed thick corrosion products around the crevice area, with a deep trough just outside the crevice. The outer layer of corrosion products was a green colour with an orange-brown product beneath the outer layer. In addition to the crevice corrosion there were broad pits on the open surface on one side of each NAB specimen. The depth appeared similar to that in the crevice, but the corrosion product beneath the green outer layer was white, not orange as in the crevice areas.

The NAB specimens coupled to Z100 with a 1:10 area ratio were similar in appearance to those described above. The corrosion outside the crevice area appeared deeper than with the smaller area ratio and copper crystals were clearly visible inside the crevice on the NAB surface. There

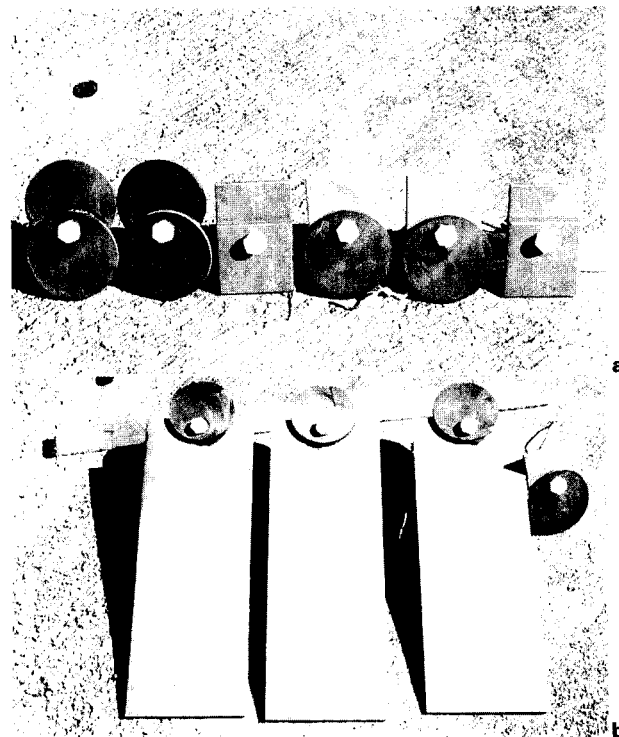
3 Appearance of galvanic couples exposed to sea water plus 0.7 mg L^{-1} chlorine for 63 days

In general there was far less corrosion product on the NAB specimens exposed to chlorinated sea water compared with those exposed to unchlorinated sea water. The NAB specimens coupled to NAB showed some corrosion products at the edge of the crevice, but the corrosion was only superficial.

The NAB specimens coupled to Z100 at an area ratio of 1:1 also showed corrosion products around the crevice, but again the attack was only superficial. The NAB specimens coupled at the higher area ratio (1:10) showed deep attack at the crevice, similar to that seen in unchlorinated sea water. In addition there was some lesser attack at the crevices created by the polypropylene fastener. Although no significant pitting was observed on the NAB outside the crevices, there were tiny mounds of corrosion product on the open surface which could have been 'incipient' pits.

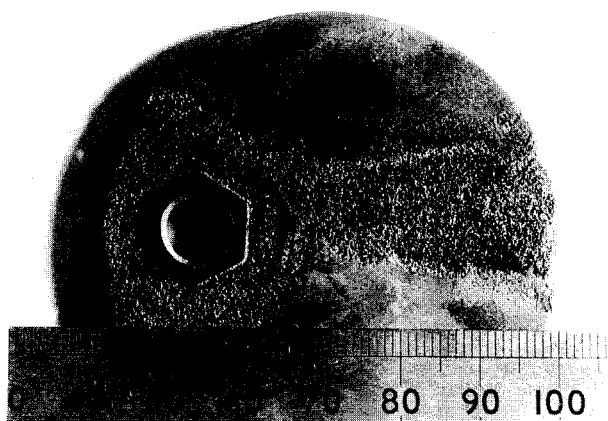
4 Appearance of corrosion on NAB outside crevice after coupling to Z100 in natural sea water

was also crevice attack around the polypropylene nut and screw head which was not seen at the lower area ratio. Figure 4 shows the appearance of an NAB specimen coupled to Z100 with an area ratio of 1:10 in natural sea water. The specimen was pickled in cold 10% sulphuric acid to remove the corrosion products. The extensive attack

around the crevice created by the nut and elsewhere is clearly visible.

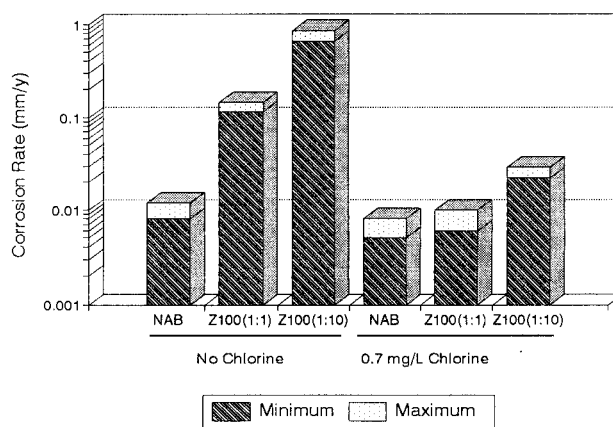
5 Corrosion rate of NAB galvanic couples in sea water at $\sim 25^\circ\text{C}$

Figure 5 shows the minimum and maximum corrosion rates calculated from the weight losses for all exposure conditions. No corrections have been made for metal loss due to localised corrosion, and so some of these figures, particularly in natural sea water, are higher than the 'true' general corrosion rate. The results show only the typical amount of scatter for this kind of test.

A number of points are immediately apparent. In natural sea water the corrosion rate of NAB is very low, typical of copper alloys, but coupling to Z100 greatly accelerates the rate of metal loss. Increasing the area of Z100 coupled to the NAB has the effect of increasing the corrosion rate by a factor of ~ 5 . Much of this is probably accounted for by the increase in localised corrosion outside the crevice.

In chlorinated sea water the corrosion rate for NAB coupled to itself was less than in natural sea water and hardly increased when coupled to an equal area of Z100. Coupling to ten times the area of Z100 produced a

substantial increase in the corrosion rate, but still much less than seen in natural sea water. Most of the increase appears to be due to localised rather than general corrosion.

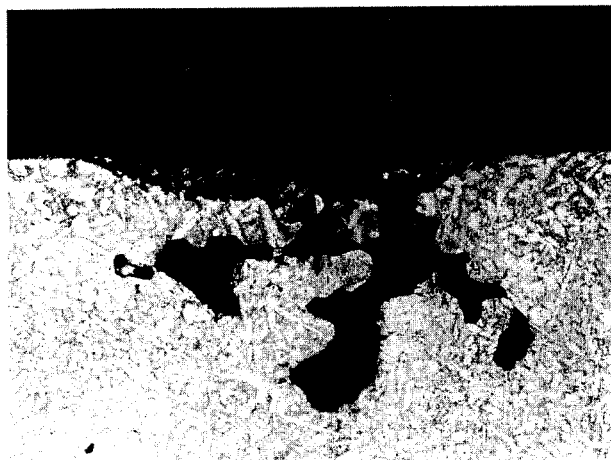
7 Microsection ($\times 50$) of specimen shown in Fig. 6, etched electrolytically in 1% chromic acid

Both specimens were electrolytically etched in 1% chromic acid to show the structure at the corrosion sites. Figure 7 shows a low magnification picture of the attack on specimen 1. The corrosion is broad and shallow, with an open series of casting pores beneath. Figure 8a and b shows details of the corrosion in the pits on specimens 1 and 20 respectively. These show that the α phase particles are being removed by corrosion of the long, thin needles of κ_{III} phase around them.

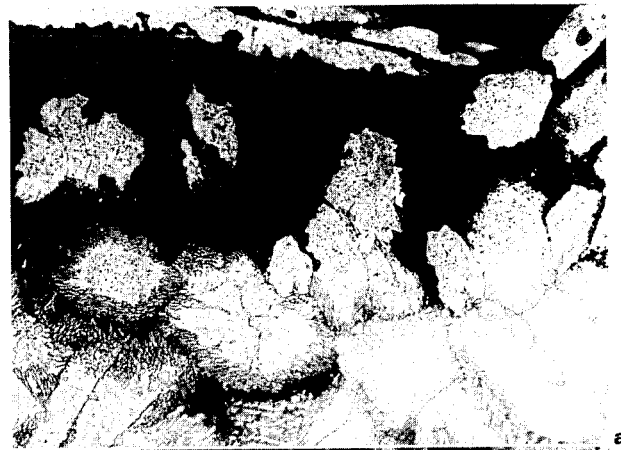
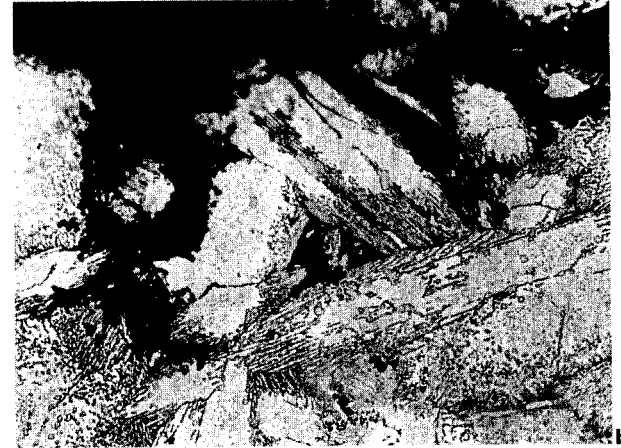
8 Microsections ($\times 500$) of corroded NAB after coupling to Z100 in (a) natural sea water and (b) chlorinated sea water (area ratio 1:10), etched electrolytically in 1% chromic acid

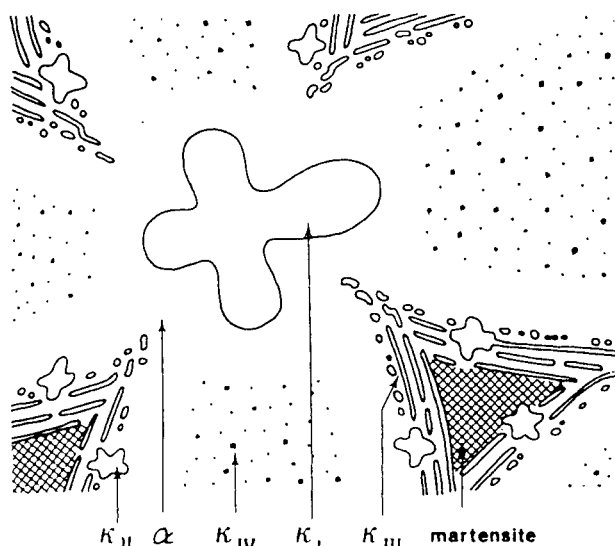
9 Schematic representation of microstructure of NAB (from Ref. 2)

The microstructure and composition of the phases in nickel-aluminium bronze (AB2) are complex, and were only explained in detail relatively recently.^{1,2} On cooling, the high temperature β phase transforms to α and κ phases. Four distinct κ phases have been identified, and a schematic of a typical microstructure is shown in Fig. 9 (from Ref. 2). The κ phases are all intermetallics, enriched in aluminium and iron and/or nickel.² Figure 9 also shows a martensite phase. This is what is often referred to as 'residual β ' phase, and it is produced when the alloy is cooled too rapidly after thermal processing and the β phase does not fully transform into α and κ .

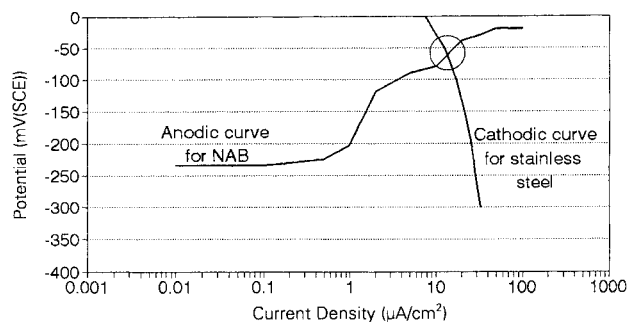
10 Polarisation curves showing corrosion of NAB coupled to Z100 in natural sea water: area ratio 1:1

To explain the behaviour in natural sea water the cathodic curves for stainless steel from Scotto *et al.*⁴ have been combined with the unpublished anodic curves for NAB of Maselkowski and Francis.⁵ This is shown in Fig. 10. The solid lines are for equal specimen areas and it can be seen that the net result, indicated by the circle, is an increased potential for the NAB to about -70 mV(SCE) and a high current in excess of $10 \mu\text{A cm}^{-2}$. When localised

corrosion of NAB is occurring at the κ_{III} phase, the potential is typically observed to increase to about -50 mV(SCE) .⁶ The corrosion rate at $12 \mu\text{A cm}^{-2}$, as shown in Fig. 10, is about 0.2 mm/year, using Faraday's law. However, as the attack is confined principally to the κ_{III} , an increase in the corrosion penetration rate by a factor of ten could occur, assuming 10% of the exposed surface is κ_{III} , i.e. 2 mm/year.

The attack on the NAB when coupled to ten times the area of Z100 hardly increased in depth compared with a 1:1 area ratio. This is probably because the efficiency of the cathode with the biofilm is so great that an increase in area makes only a small difference to an already high corrosion rate. When the area of the cathode is increased, the effect is to push the cathodic curve in Fig. 10 to the right. This results in a more positive potential and a higher corrosion current.

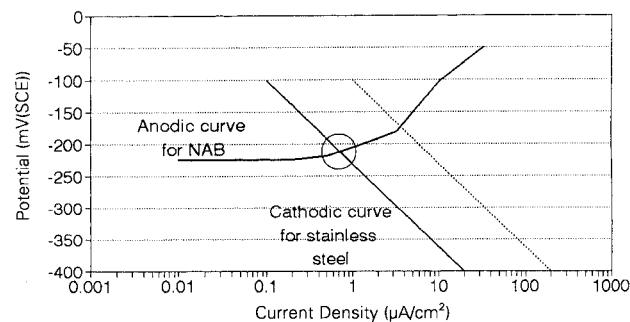
— 1:1 area ratio; 1:10 area ratio

11 Polarisation curves showing corrosion of NAB coupled to Z100 in chlorinated sea water

The anodic curve for NAB in chlorinated sea water from Ref. 5 has been combined with a composite cathodic curve for high alloy stainless steel derived by Sintef⁷ in Fig. 11. The solid lines are for an area ratio of 1:1 and it can be seen that the potential is hardly increased from that of freely corroding NAB. The current is very low, giving an average corrosion rate of 0.011 mm/year. Selective phase attack of the κ_{III} phase did not initiate, probably because the corrosion rate was so low that an occluded cell could not easily form. Even in the crevice areas there was no indication of localised attack.

When the area of the cathode is increased tenfold this effectively increases the cathodic curve by an order of magnitude as shown by the dotted line in Fig. 11. This results in a small ennoblement of potential of about 50 mV but increases the current by a factor of about 5. This produces an average corrosion rate of 0.056 mm/year, which would be equivalent to a penetration rate of 0.56 mm/year if only 10% of the exposed surface were κ_{III} . The potential ennoblement seems to be insufficient to initiate selective phase corrosion outside the crevices.
